Engineering and Inspections

622 City Park Avenue
New Orleans, LA 70119

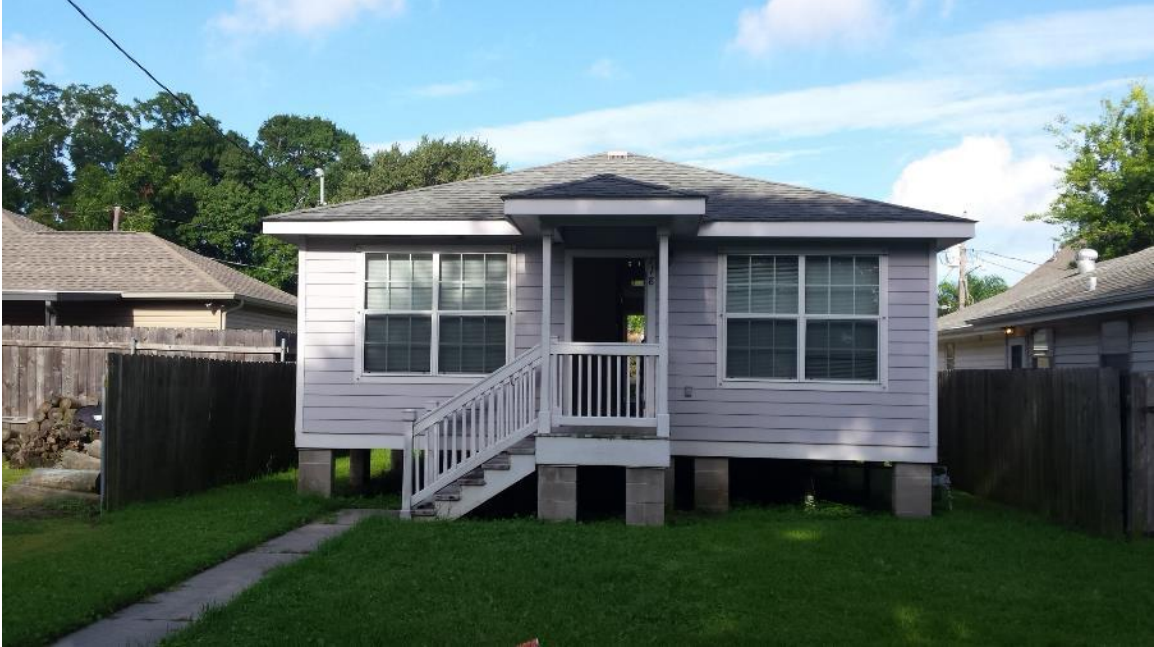
This is a view of the front of the property.

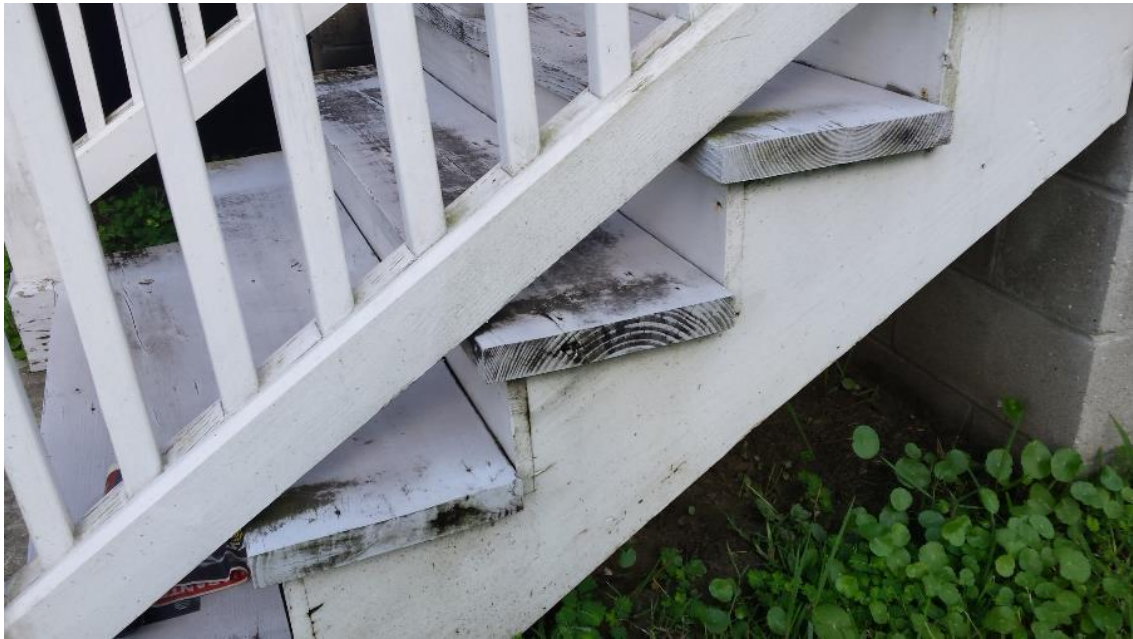
This is a view of discoloration and moisture effects noted at the front stair treads. In our opinion, this discoloration is premature and indicates that these treads were not sealed properly.

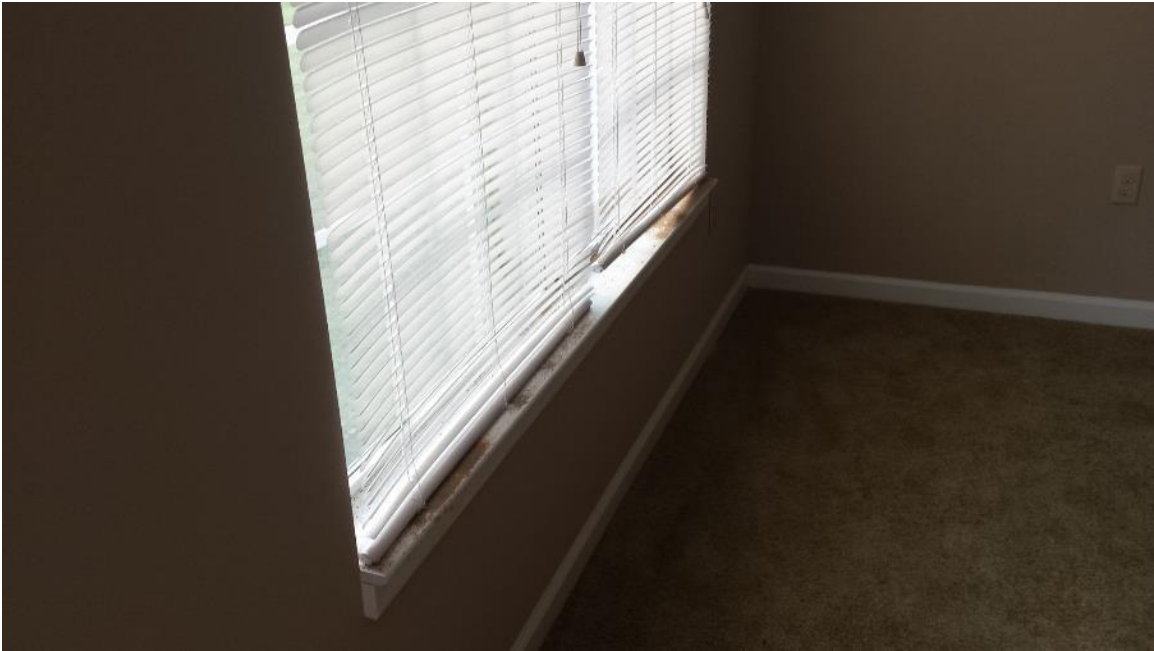
This is a view of the living room windows.

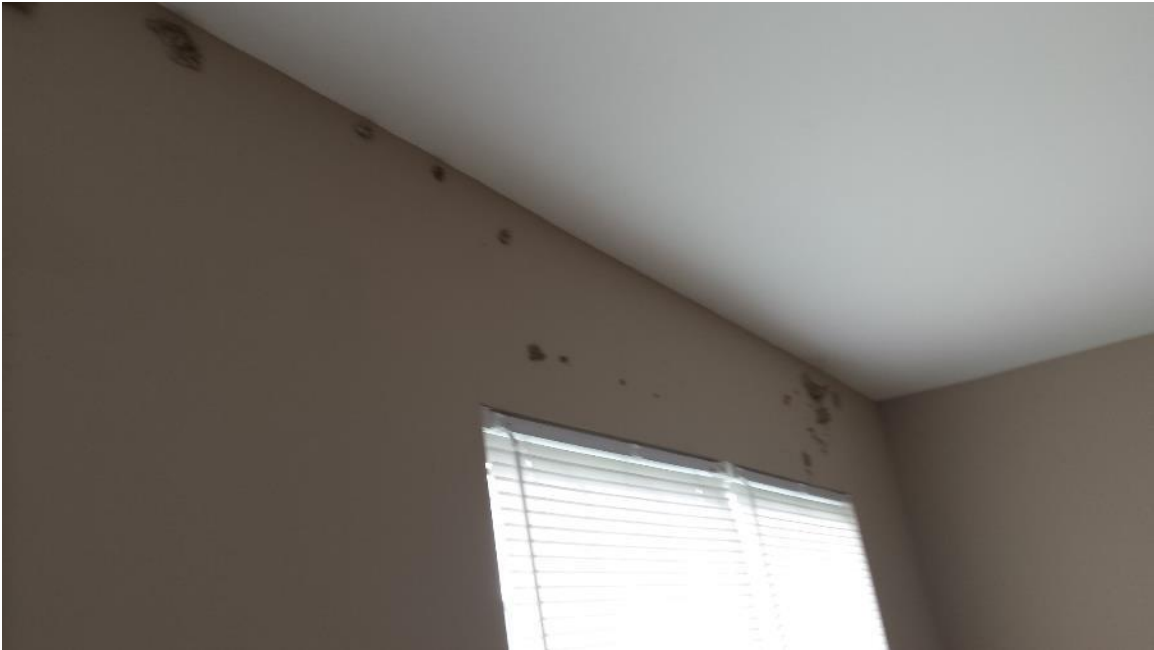
Since we are not licensed pest control operators, we cannot address the presence of wood destroying organisms or identify damages caused by them. Mr. Avegno's report indicates termite damage and infestation on the front wall of the living room. This is a view of the termite damage noted in Mr. Avegno's report. Damages to some degree to the underlying wall framing can be expected. However, the extent of these damages cannot be ascertained without removing the wall coverings.

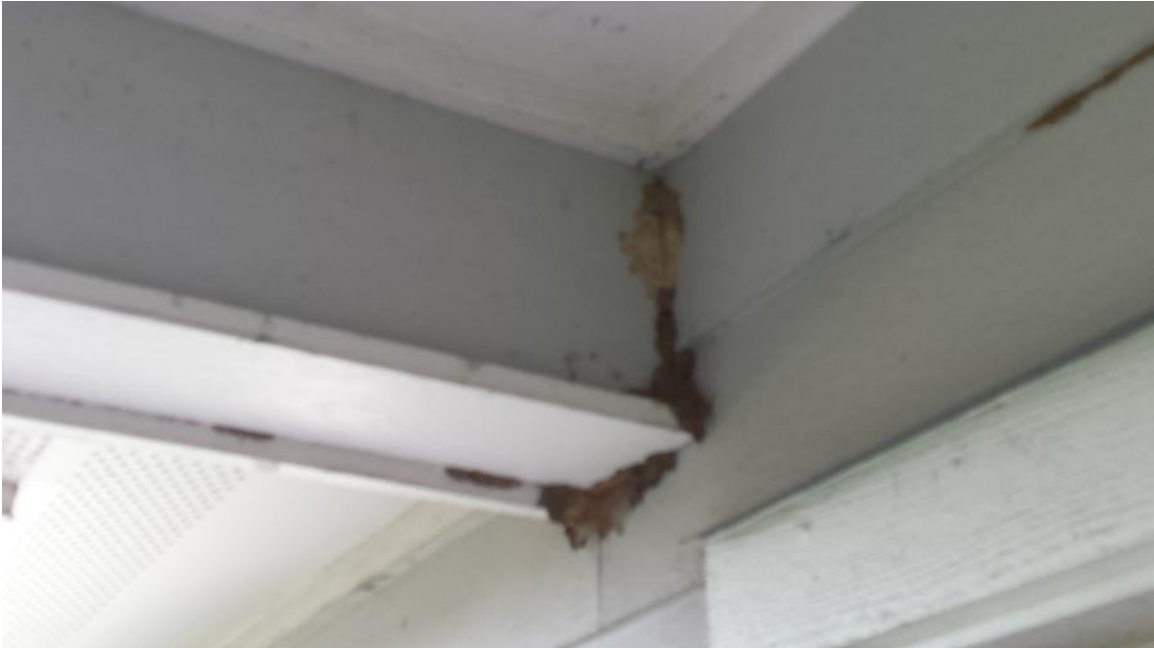
The evidence of apparent termite damage extends to the outside of the front wall of the house.

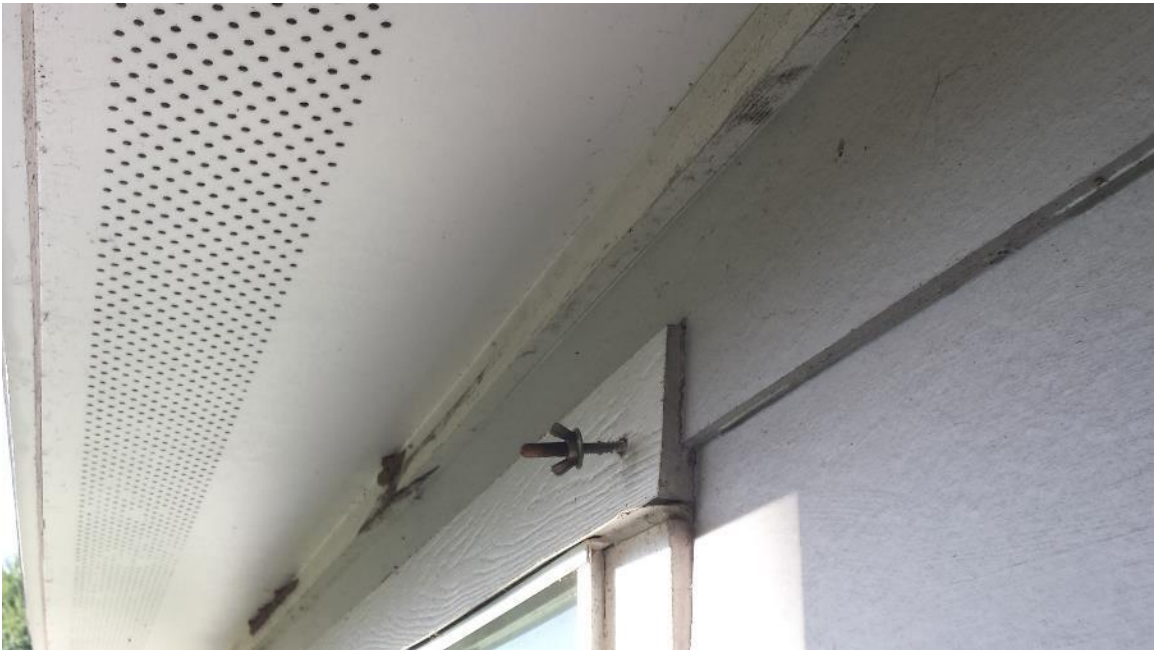
This is another view of the apparent termite damage on the outside of the front wall.

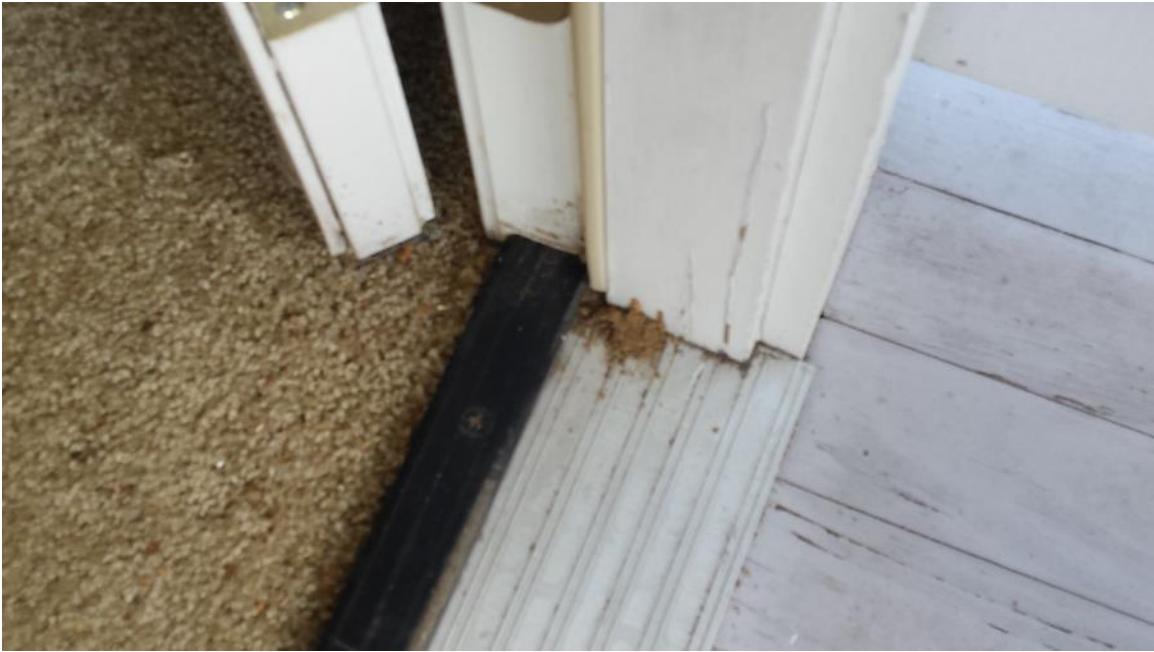
This is additional apparent termite damage at the front door threshold.

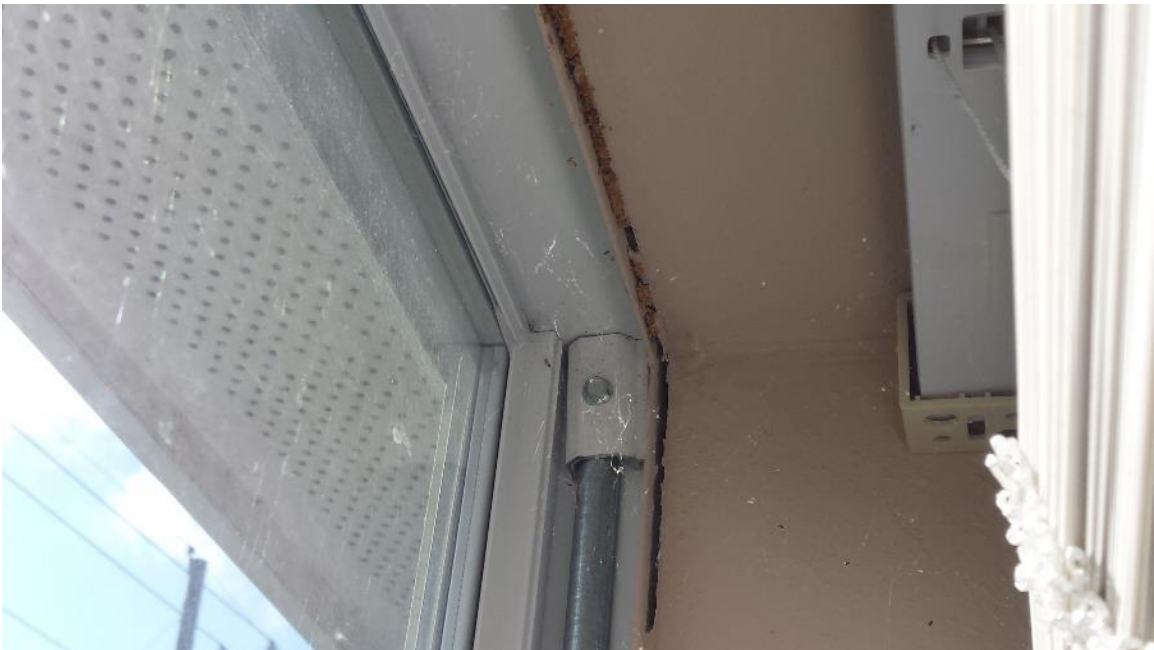
Note that there are separations between the window frames and the gypsum wallboard inside the window casings. Such separations are typically an indication of moisture inside the wall cavity.

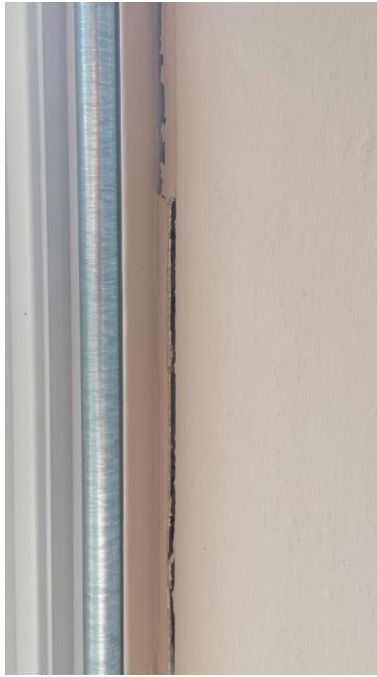
This is another view of the separations between the window frames and the casings.

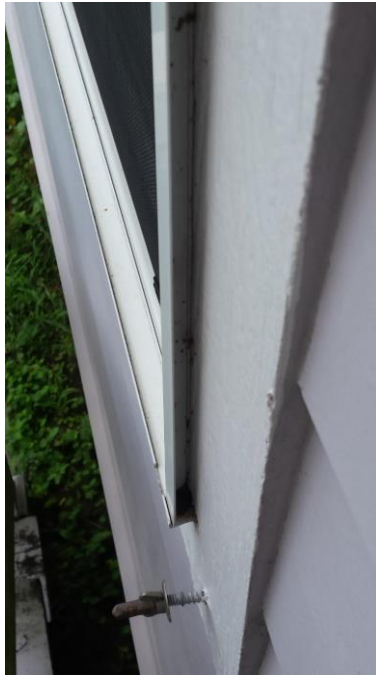
Note that the windows are not flush with the exterior trim, which is a condition that will allow moisture intrusion into the wall cavity. This installation is not consistent with Detail 3 on Sheet DT3 of the Dodds plans. This condition indicates that either the windows were not installed properly or that the jambs were not sized for the thickness of the walls.

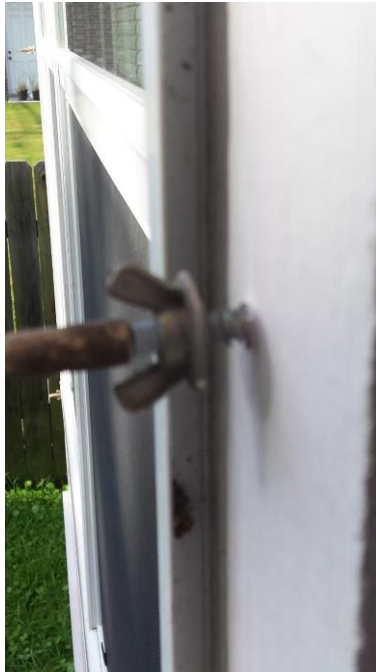
This is a close-up view of the condition shown in the photograph above.

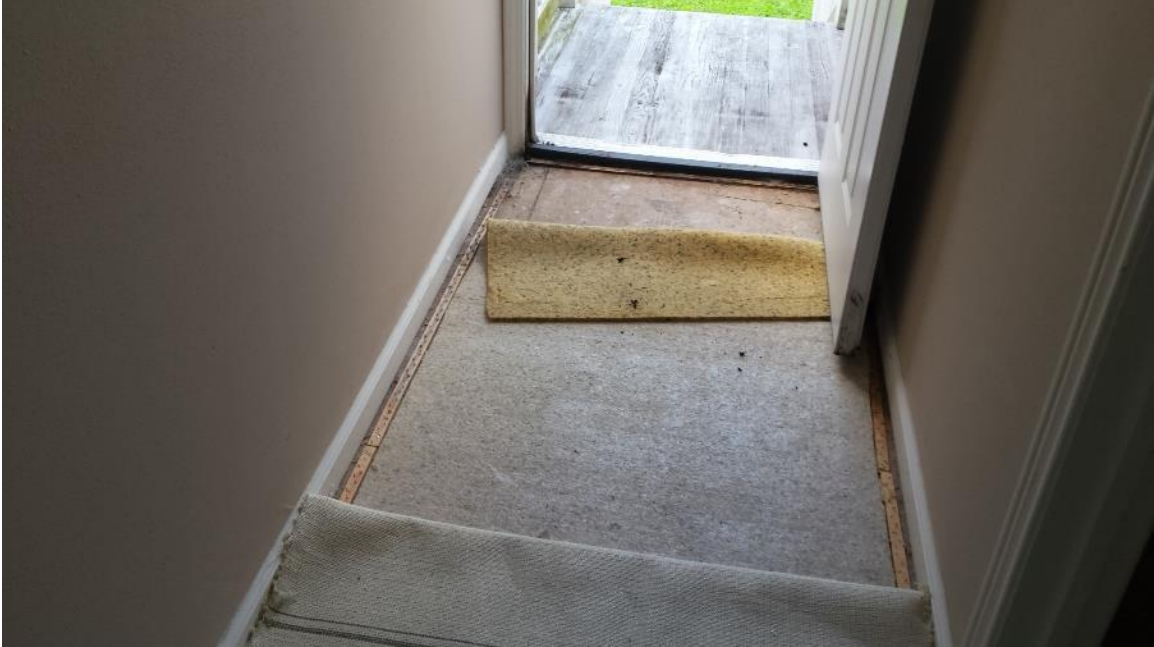
This is a view of the rear of the hallway at the rear door frame.

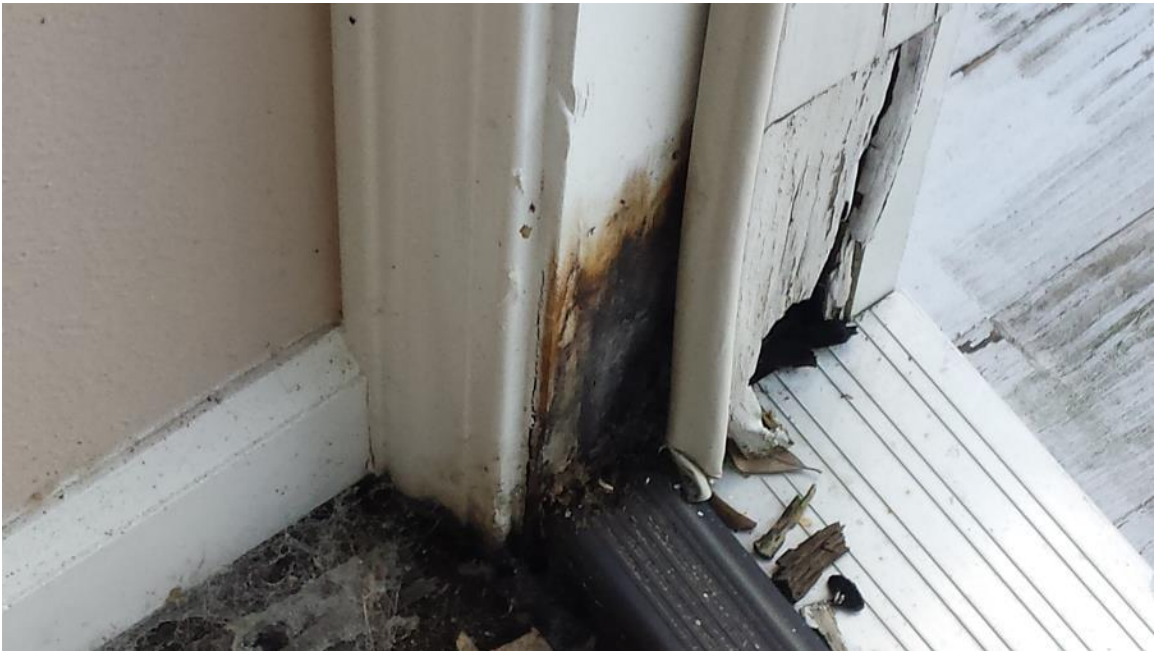
Note the water damage that is the result of leakage of the door and frame.

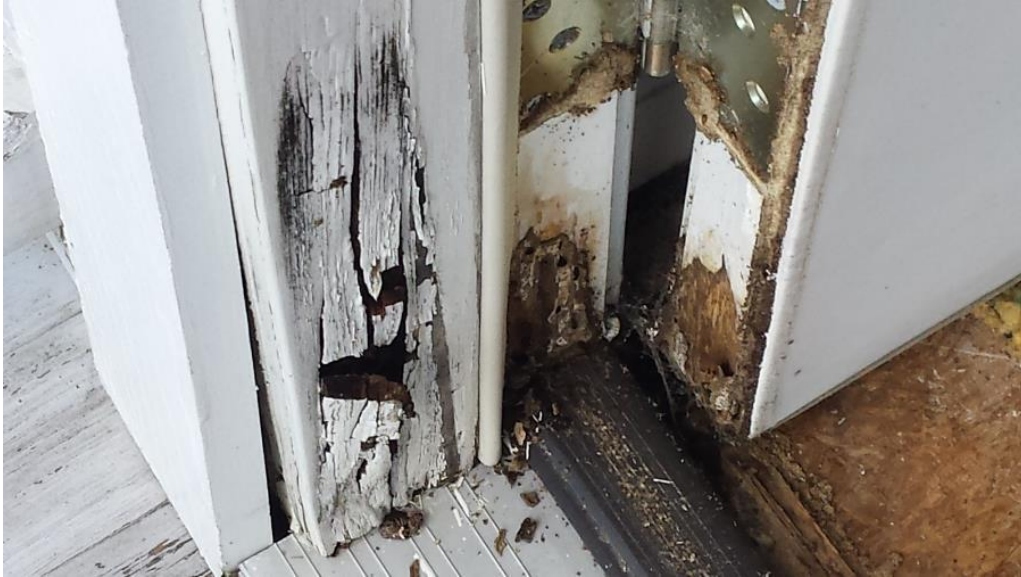
This view shows that both sides of the frame leak and have considerable moisture damages.

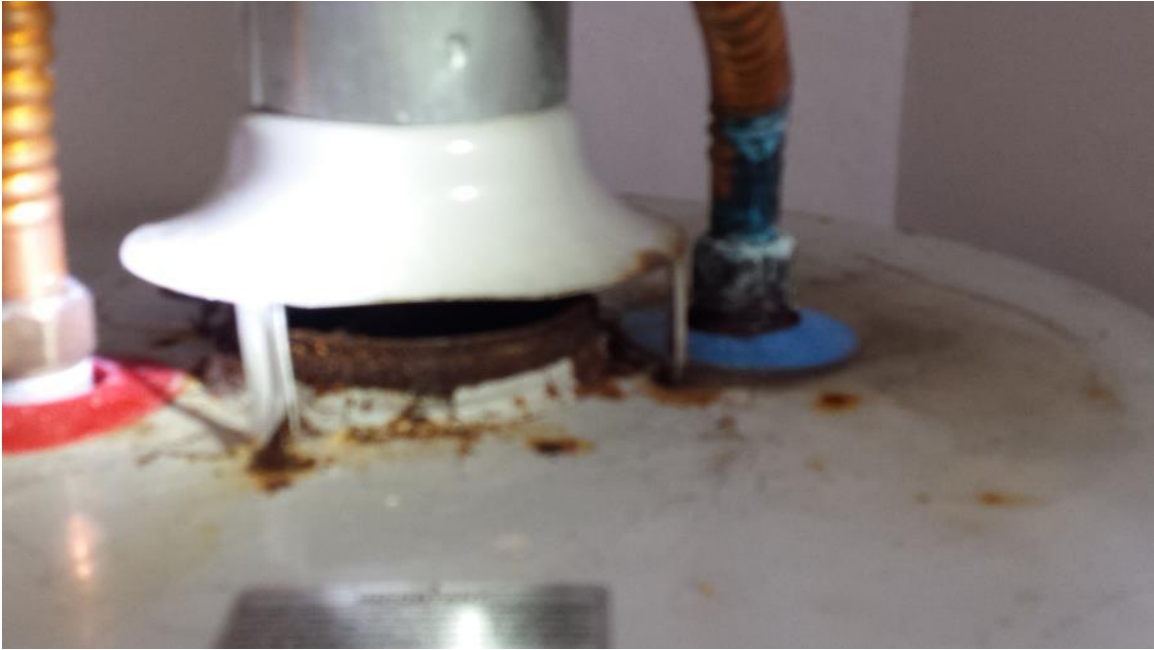
It is our understanding that there has been some discussion between the parties involved in this litigation regarding whether or not the roof has leaked. In our opinion, this photograph shows that the water heater vent penetration leaks, as evidenced by the rusting and damages visible at the top of the water heater.

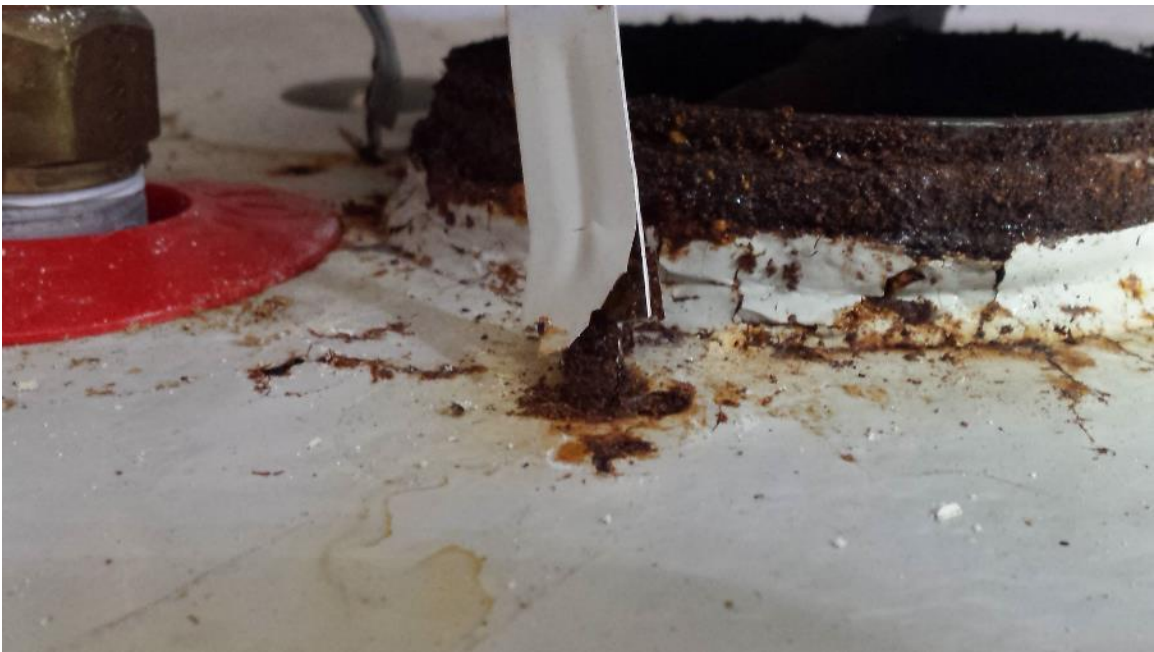
This is a close-up view of the rust damages to the top of the water heater.

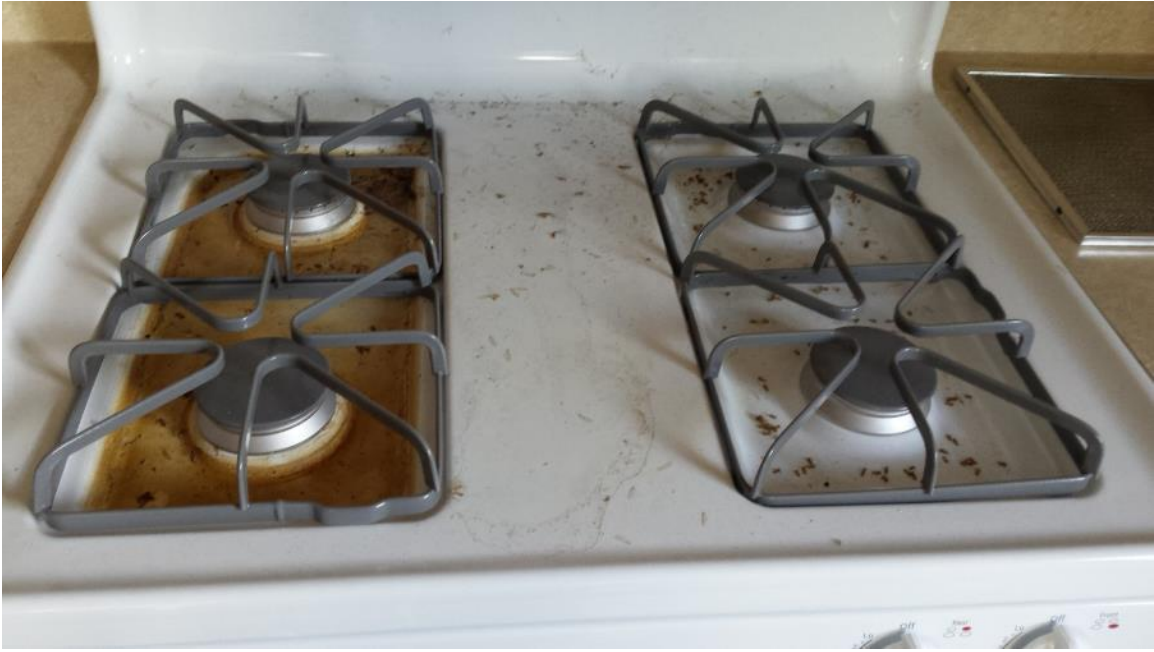
This is a view of the top of the gas range. The rusting and debris on the top of this range indicates that the kitchen exhaust vent pipe penetration also is leaking.

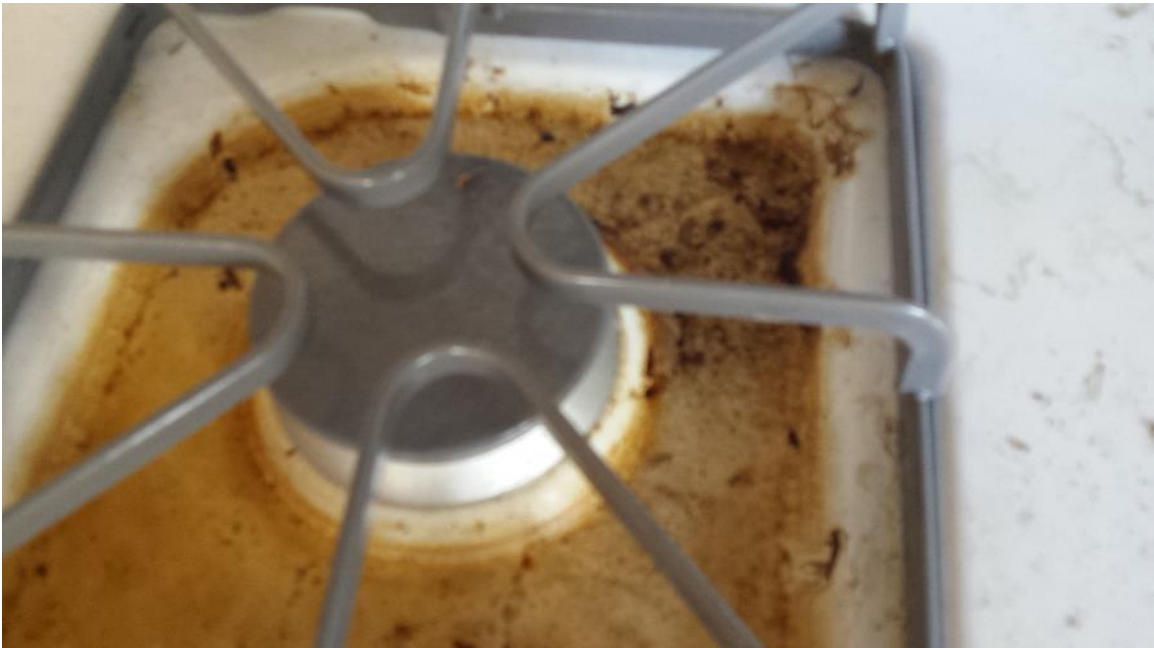
This is a close-up view of the rusting noted on the top of the range, and water has accumulated at least $\frac{1}{4}$ " deep in this burner element. In our opinion, these conditions confirm leakage from the exhaust fan vent penetration.

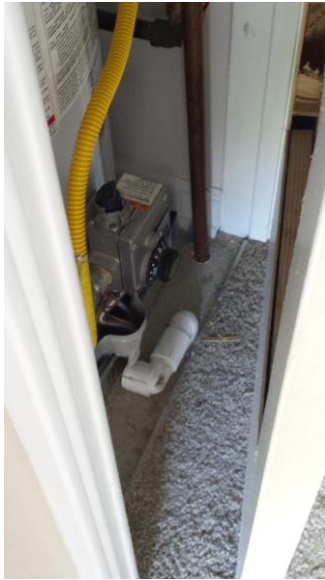
The floor plan shown on Sheet 3 of the Dodds plan calls for the water heater to be installed above the dryer on a shelf that is specified in Detail 6 on Sheet DT3 of the plans. The water heater was relocated to a closet off of the rear hallway. Note that there was so little clearance between the closet door and the water heater that the contractor cut out part of the hollow core door so that the closet door could be closed. It is our understanding that there has been some discussion regarding whether that this house could have been rented. In our opinion, the proximity of the water heater pilot mechanism to this door is an extremely unsafe condition, and we do not recommend occupancy of this unit until this condition is repaired.

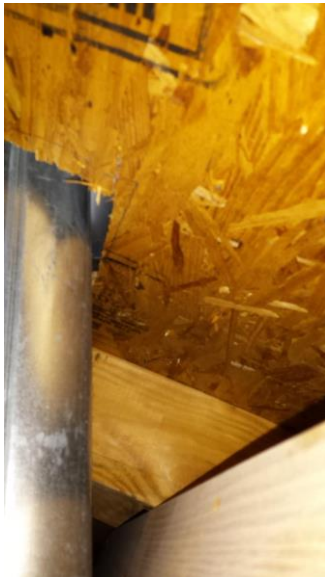
Similarly, the International Residential Code requires a 1-inch clearance between the edge of this water heater vent pipe and the flammable roof decking. The inadequate clearance shown in this photograph is a potential a fire hazard.

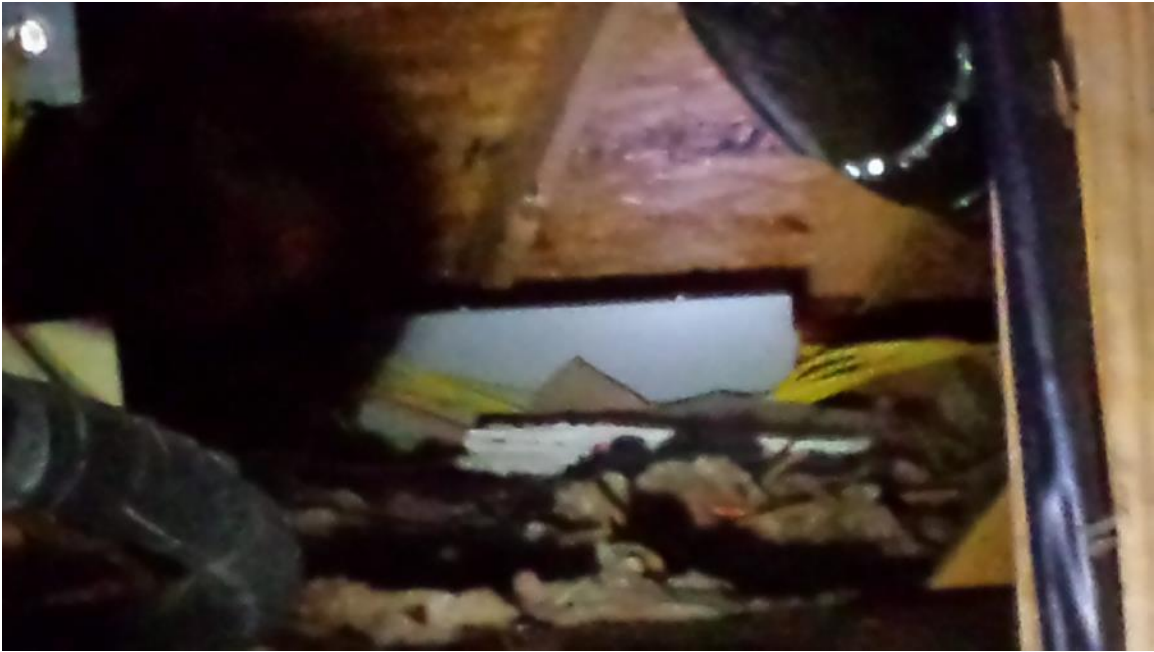
Sheet E-01 of the Dodds plans locates the electrical panel on the outside of the house. The Titan report does not acknowledge that the panel location was changed by the contractor and that this inaccessible junction box in the left front of the attic does not meet current code. The Titan report also does not reflect the costs associated with eliminating this inaccessible junction box.
